HOUSATONIC RIVER BASIN
WOLCOTT, CONNECTICUT

CHESTNUT HILL DAM CT 00298

PHASE I INSPECTION REPORT NATIONAL DAM INSPECTION PROGRAM

JUN 1981

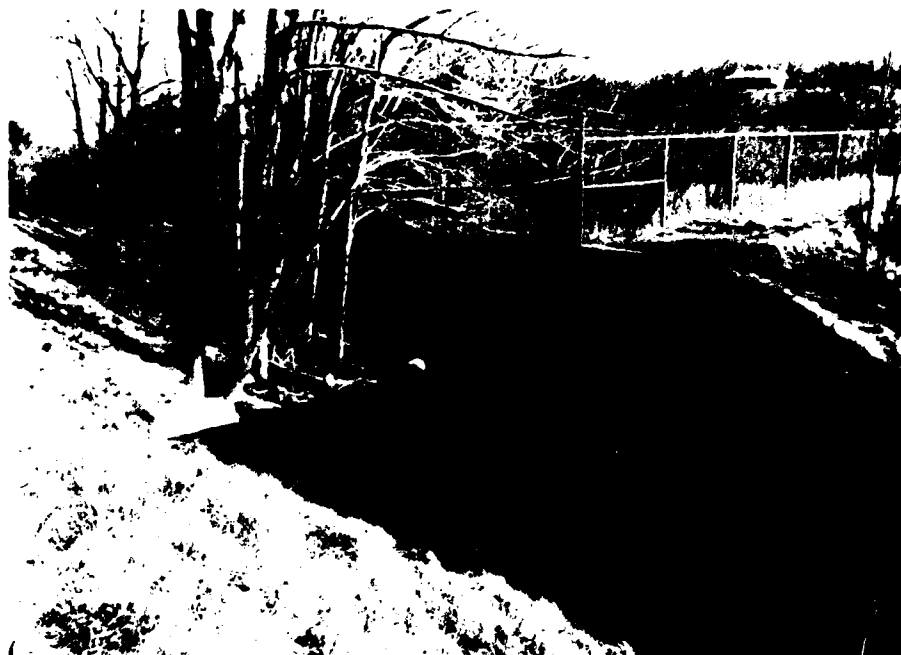
Spillway - The spillway is in fair condition (Photo 5). The concrete spillway crest is in good condition with very little deterioration of the concrete; however, the concrete training wall is spalled. The stop planks are in good condition. The design drawings of the project show the toe of the side slope to the left of the dam meeting the top of the spillway end wall approximately 15 feet from the edge of the spillway; however, it was observed that the slope actually meets the end wall only 3.8 feet from the edge of the spillway. The auxiliary spillway (end wall) appears to have been partially covered by placement of fill (Photo 5), thereby reducing the combined spillway capacity.

6. Continued spalling of the right spillway training wall could decrease the stability of the wall.
7. The fill which has been placed over the spillway end wall reduces the total discharge capacity of the project.

Photo 5 - Spillway. Note spalling of right training wall and short section of end wall exposed at left of spillway (4/22/81).

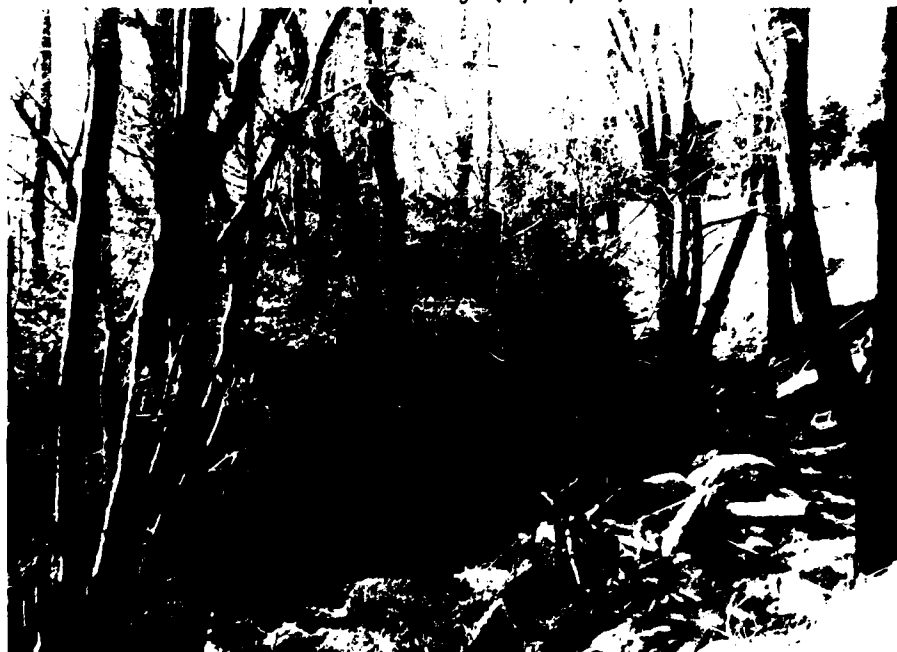
The spillway discharge channel is poorly defined, is vegetated with trees and brush, and contains much debris (Photo 6). The dry-laid masonry wall along the right side of the channel, probably dating from the original dam, is in good condition as is the abutment between this wall and the concrete spillway training wall.

8. The trees, brush and debris in the spillway discharge channel and trees growing from the channel wall will reduce spillway capacity and increase deterioration of the wall.

Photo 6 - Spillway discharge channel and dry-laid masonry wall. Note trees and debris in channel (4/22/81).

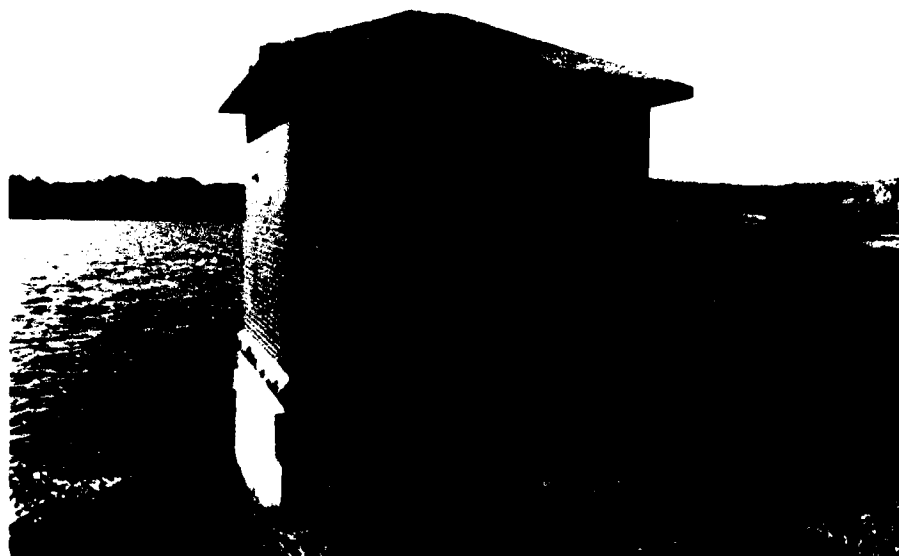
Photo 7 - Gatehouse (4/22/81).
